Journal of the Nevada Water Resources Association

Volume 2, Number 1

A study of ancient trees rooted 36.5 m (120') below the surface level of Fallen Leaf Lake, California

JOHN A. KLEPPE, EE Department, MS 260, University of Nevada, Reno, Reno, NV 89557-0153 (kleppe@ee.unr.edu)

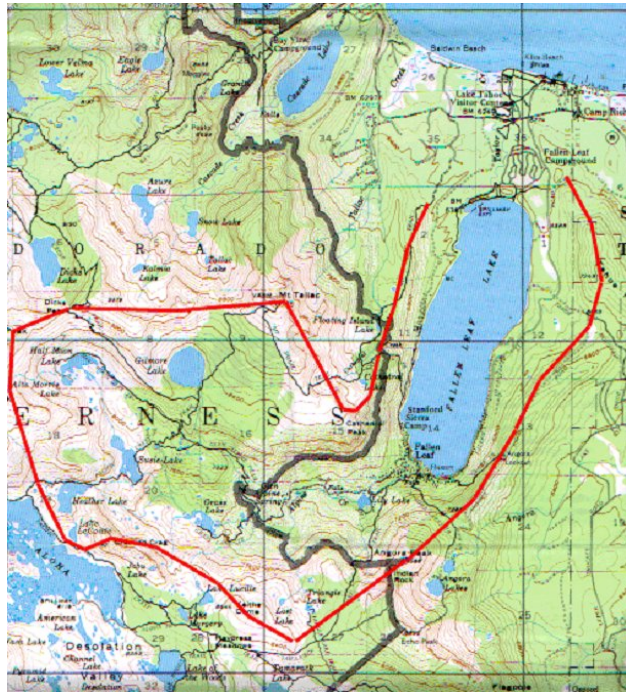
Figure 1. Fallen Leaf Lake with watershed boundary marked by red line

Fallen Leaf Lake is a small lake located in the Tahoe Basin near South Lake Tahoe, California, Figure (1). The lake has a surface area of 5.2 km² (2 square miles) and drains into Lake Tahoe. The watershed for Fallen Leaf Lake covers an area of approximately 42 km² (16 square miles) and is within the Lahontan drainage basin. A sizable portion of the drainage basin is located within the Desolation Wilderness Area, and is drained by Glen Alpine Creek into the south end of Fallen Leaf Lake. The sole outflow of Fallen Leaf is through Taylor Creek (which flows from the north end of Fallen Leaf into Lake Tahoe) which makes Taylor Creek one of the major tributaries to Lake Tahoe.

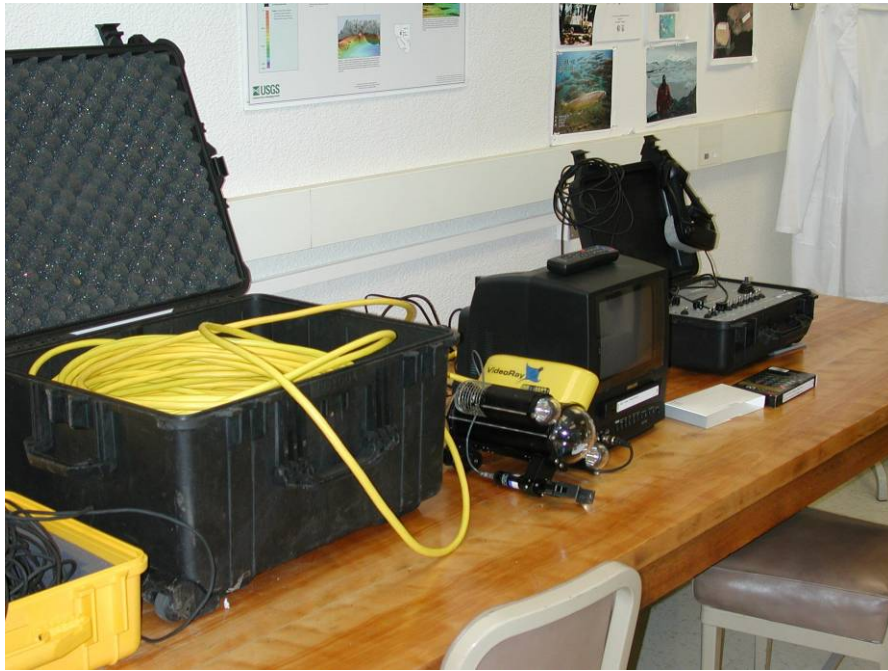
Figure 2. Remotely Operated Vehicle (ROV) with 152 m (500') tether

The author obtained a small grant to help in the study of these submerged rooted trees. He has been operating a Remotely Operated Vehicle (ROV) that can obtain high resolution color video and retrieve small wood samples down to a depth of about 152 m (500') below the lake surface. The trees are invisible to sonar since they have become completely water logged from being underwater for approximately 800 years. Visual searching has been required to locate them.

Using a remotely operated vehicle (ROV) (Figure 2), large trees were discovered that appear to have been rooted at a depth of 36.5 m (120') below the existing surface level of Fallen Leaf Lake, (Kleppe and Norris, 1999; Kleppe, 2004). Some of these trees measure over 30 m (98') tall with a circumference of over 4.5 m (15') suggesting that they were over two hundred years of age when they died.

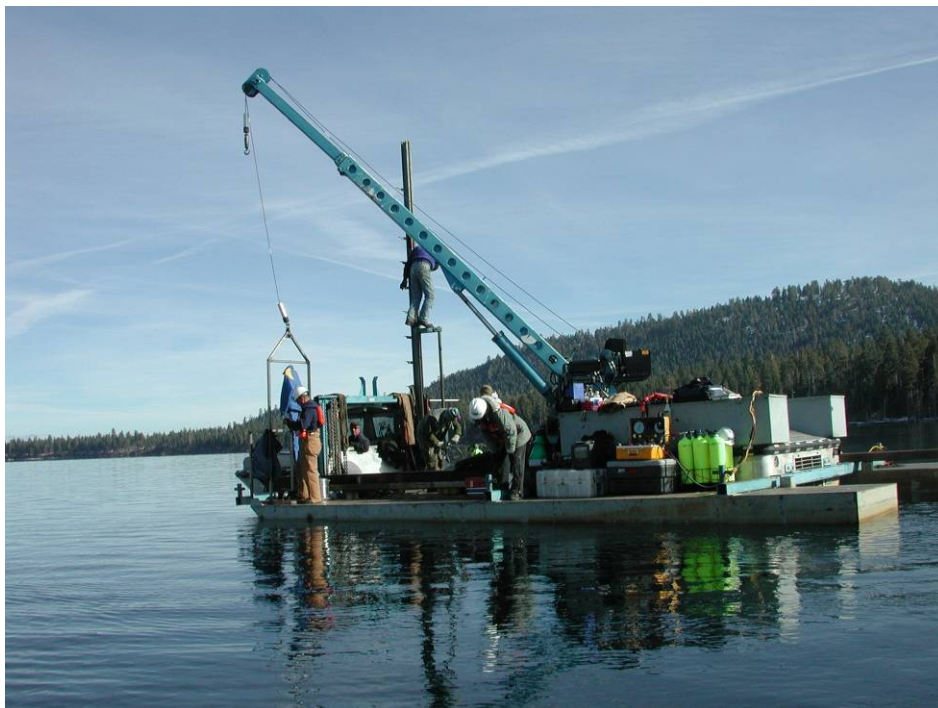
Figure 3a. Pacific Built’s floating crane the “Larc”

Since the already fallen tree died during the same period as the rooted trees, the fallen tree could be used to provide the required tree ring data. A company named Pacific Built was operating a large floating crane called the “Larc” on Fallen Leaf Lake and was available to raise the tree (Figures 3a and b).

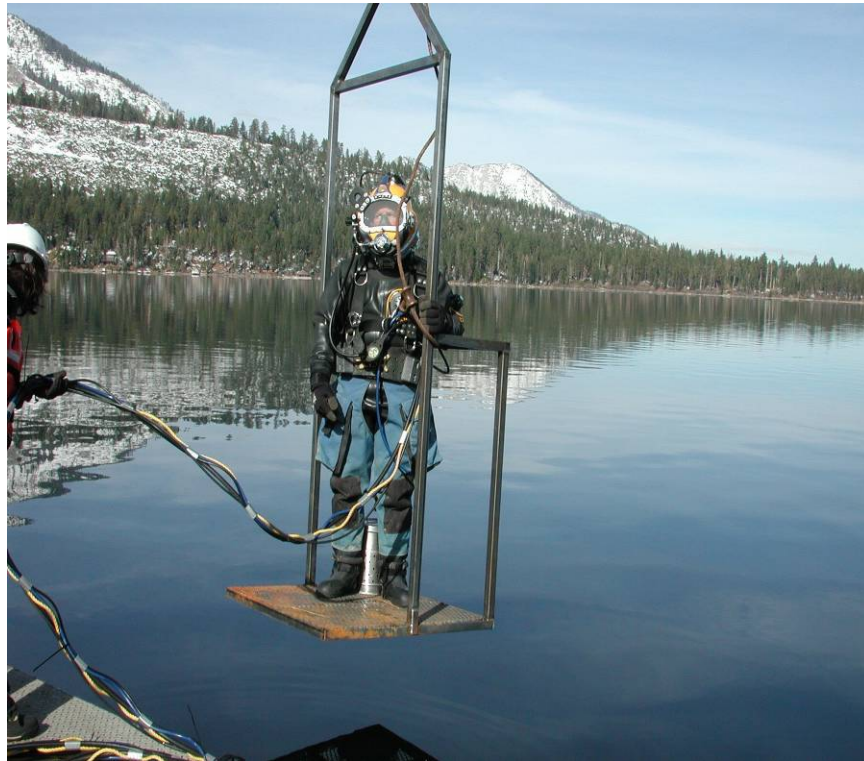
Figure 3b. Diver being lowered into the Lake by the “Larc”

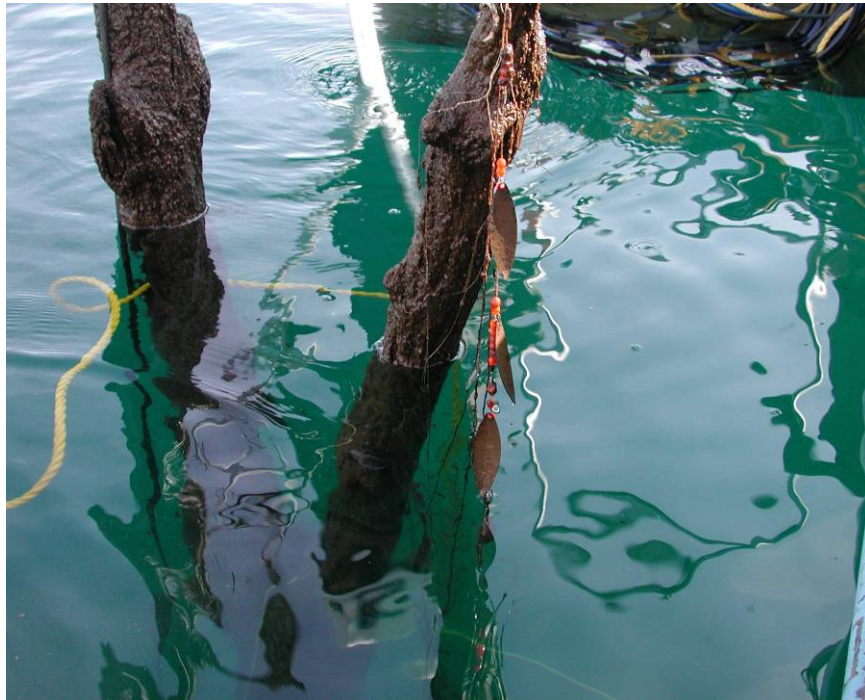
Figure 4. Top of the ancient tree being raised from the bottom of Fallen Leaf Lake

A plan was then developed and executed wherein the fallen ancient tree was raised to the surface (Figure 4), moved to shallow water, and the bottom portion of the tree cut into sections. The root structure was saved. The major remaining part of the tree was returned to the lake, at a shallower depth, for storage and retrieval if more samples were needed in the future.

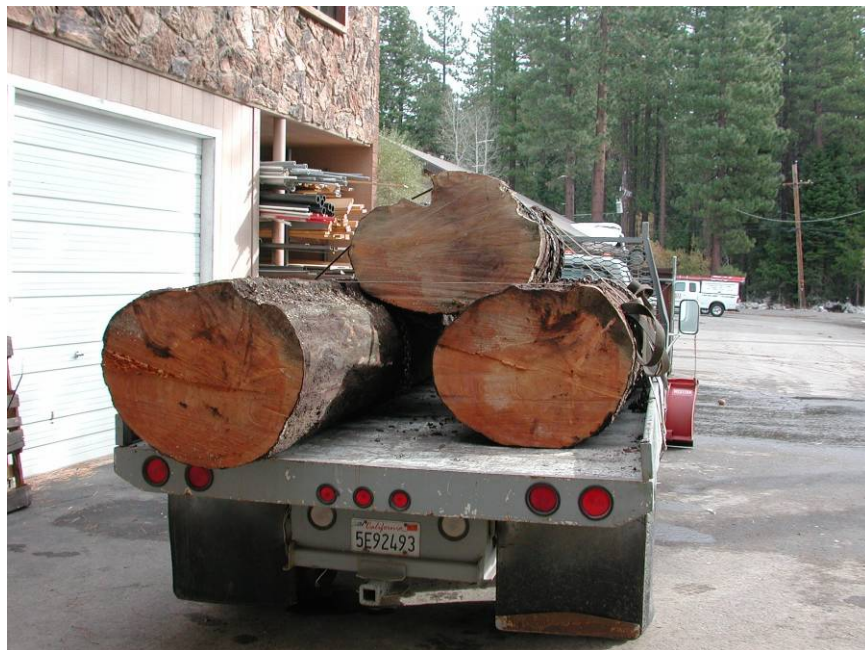
Figure 5a. Sections of ancient tree loaded on a truck

The tree sections were loaded on a truck (Figures 5a and b), and hauled to UNR for subsequent analysis and study. A tree surgeon was hired to cut several of the rounds into 10 cm (4") thick disks (Figure 6), and several samples of the tree were turned over to Dr. Biondi for preliminary analysis and study.

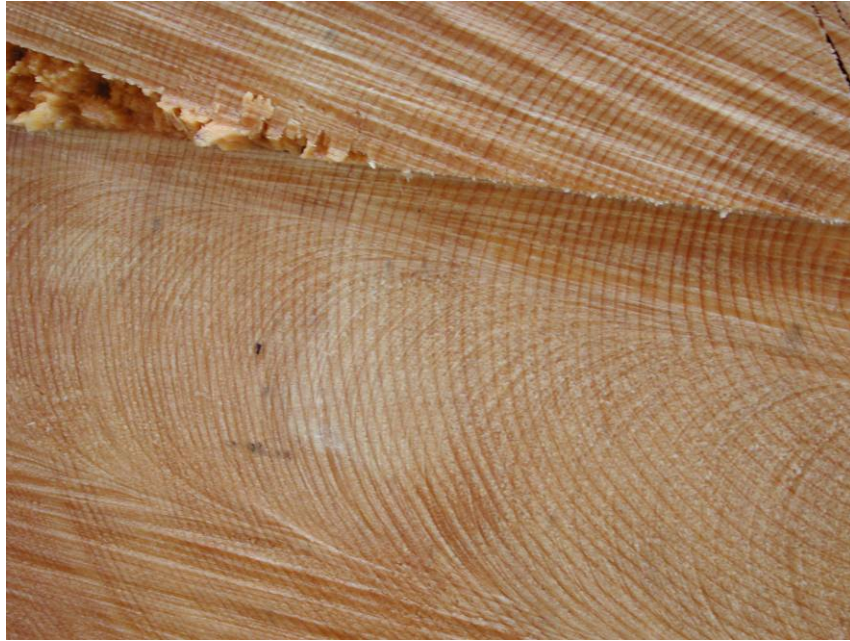
Figure 5b. Close up of cross section of ancient tree showing quality of the water logged, preserved wood

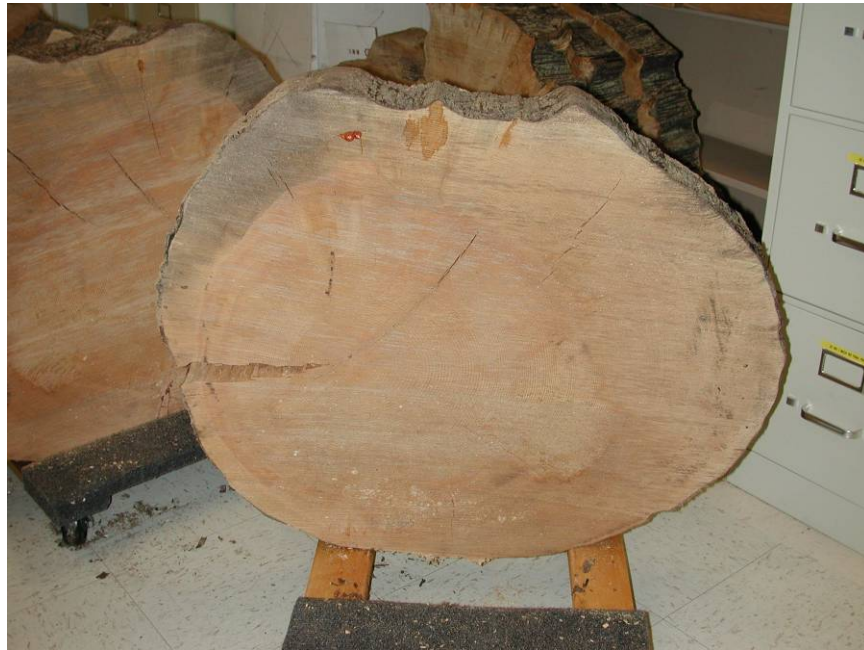
Figure 6. Sample of dried out full diameter disk 10 cm (4") thick

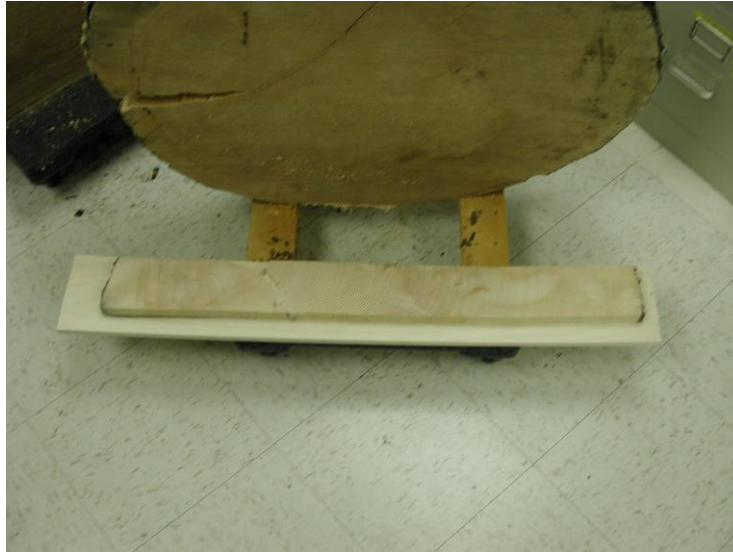
Figure 7. Sample of cross section of ancient tree

Dr. Biondi used one of the disk sections at a height of 5 m (16.5') to produce three strips 10 cm wide and spanned a full diameter (Figure 7). The remarkable condition of the ancient tree can be seen in Figure 8, which shows how well preserved the tree is considering it died in 1215 A.D. \pm 40 years. Microscope analysis clearly showed the presence of resin ducts, therefore

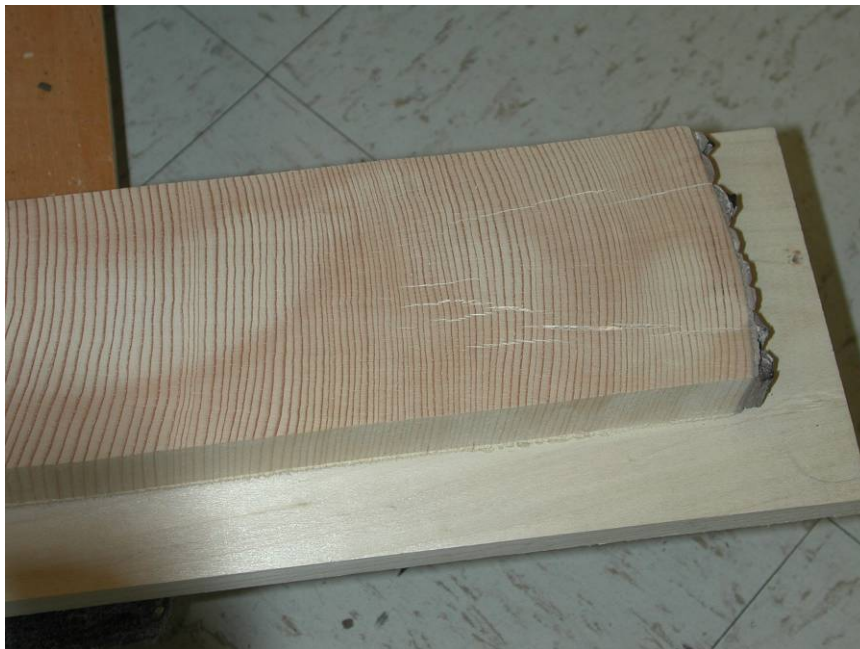
Figure 8. Example of how well the rings of the ancient tree have been preserved

it could not be a fir or a cedar (resin ducts are found in pines, spruces, and doug-firs). Based on the size, number, and distribution of the resin ducts, as well as the type of earlywood-latewood transition, the tree was determined to most likely be a pine, possibly a ponderosa. However, the final species identification (beyond what is allowed by the presence/absence of resin ducts) is difficult without additional microscopic analysis. This will be done at a later date.

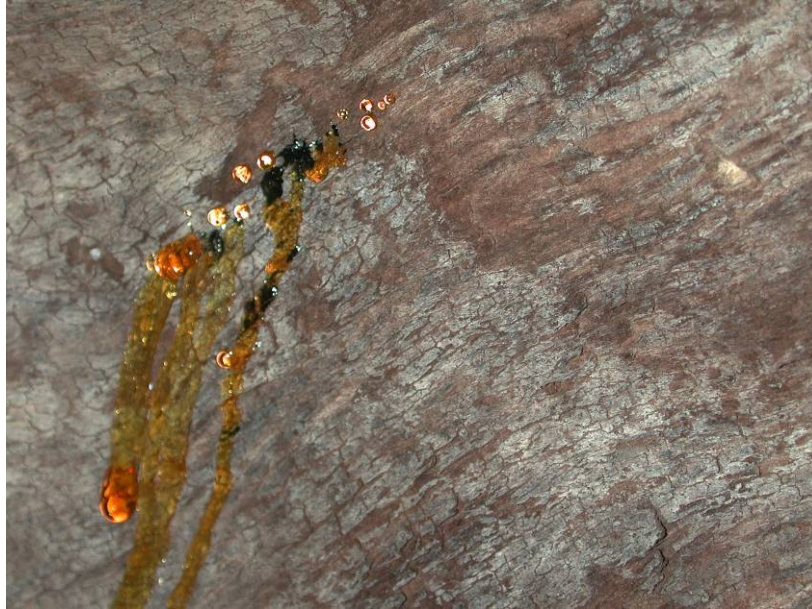
Figure 9. Photo showing a sample of the sap that began to flow from the base of the tree after cutting.

The carbon dating of the raised tree samples indicated that the tree died in A.D. 1215 \pm 40 years. There were 220 rings, indicating the tree was over 200 years old at the time it died. The tree was totally “water logged” and still had sap coming out of the root section and other parts of the tree (Figure 9). Additional sampling will be done to confirm the date of death and to match tree ring samples with other trees determined to be from this same period of time.
