Fukushima Daiichi Nuclear Power Station Unit 2 Primary Containment Vessel Internal Investigation Results (Bulletin)

January 19, 2018

TEPCO

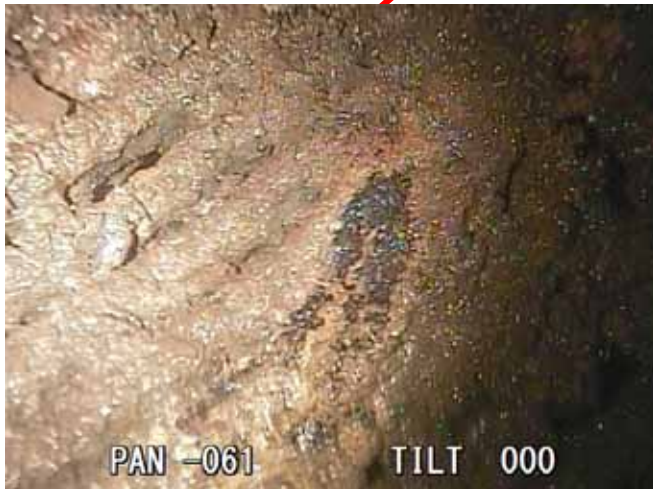
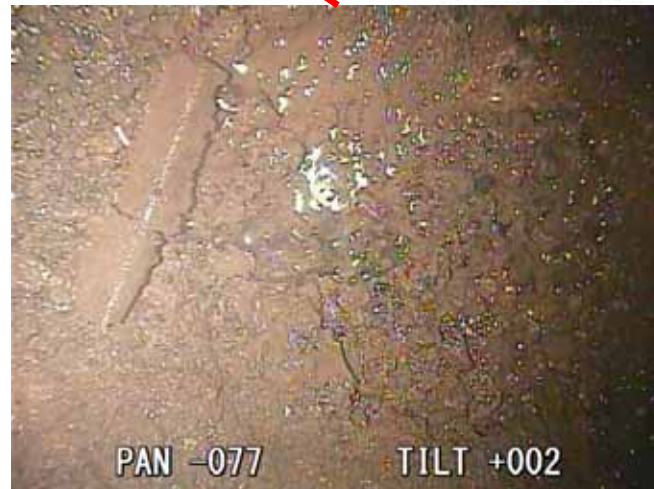
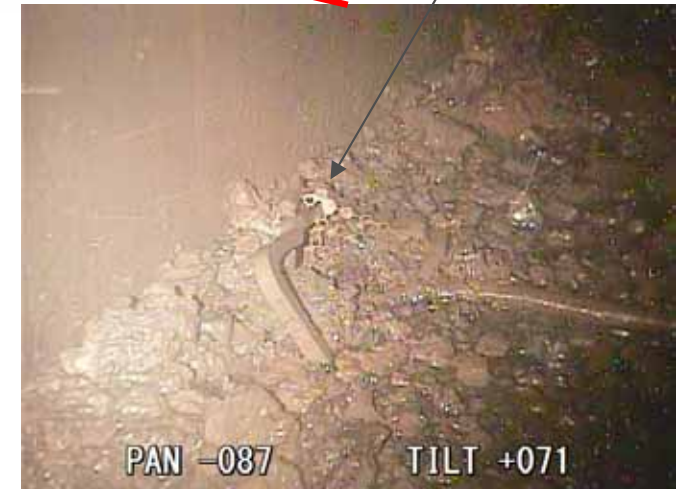
2. Internal investigation results (bulletin) (1/2)

- The internal investigation was completed as scheduled.
- The entire bottom of the pedestal was found to be covered with sandy and clay-like deposits.
- Some fuel assembly components have fallen to the bottom of the pedestal and deposits thought to be fuel debris were found in the vicinity of these fallen components.
- The CRD housing supports were found to be in the same condition as was seen during the January~February 2017 investigations.
- The investigation was completed while keeping worker exposure doses under planned limits.
- No significant fluctuations were seen in data from monitoring posts or dust monitors neither prior to, nor after, the investigation.

- The photos taken during this investigation will be analyzed and radiation level/temperature data assessed.

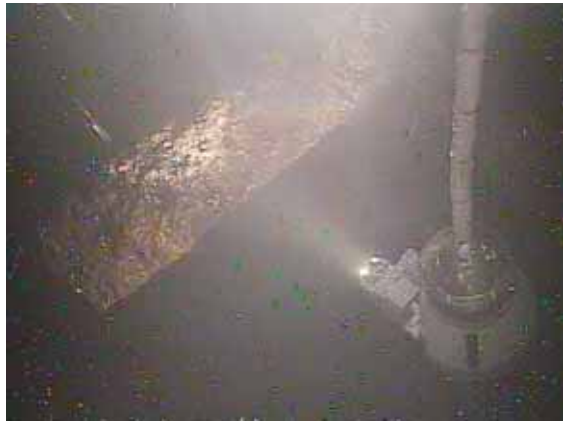
Feed from overhead camera 1
(Lowering the investigation unit)

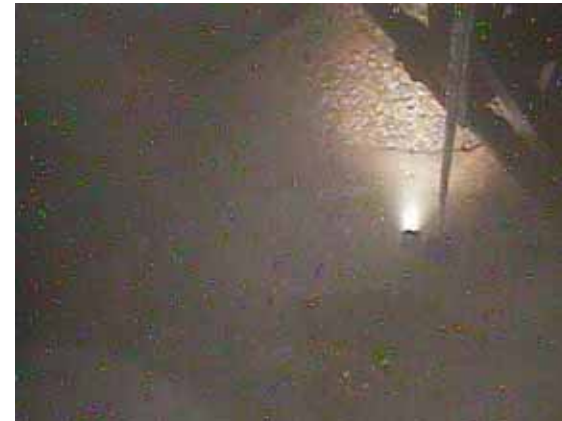
Feed from overhead camera 2
(Lowering the investigation unit)

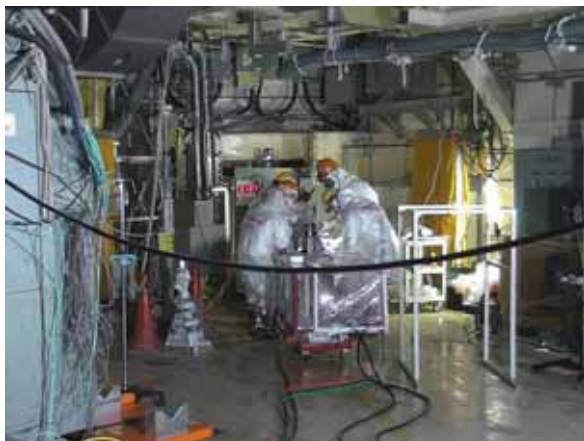
Work outside the PCV (In front of X-6 penetration)

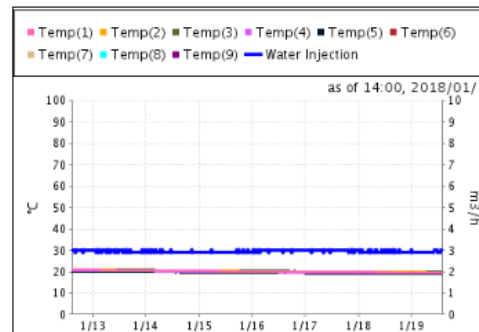
○Measurement value (2018/01/19 14:00)

Temperature Unit:°C、 Water Injection Unit:m³/h

Temp(1)	Temp(2)	Temp(3)	Temp(4)	Temp(5)	Temp(6)	Temp(7)	Temp(8)	Temp(9)	Water Injection
19.7	19.7	19.9	19.4	19.0	19.3	19.2	19.7	19.7	3.0
